# Portage Creek Sediment Remediation Project Kalamazoo, Michigan

Pre-Sediment Removal Structure Feature Assessment  
Removal Areas SA3-A, SA3-B and SA3-Access

F&V Project Number: 809930

August, 2012

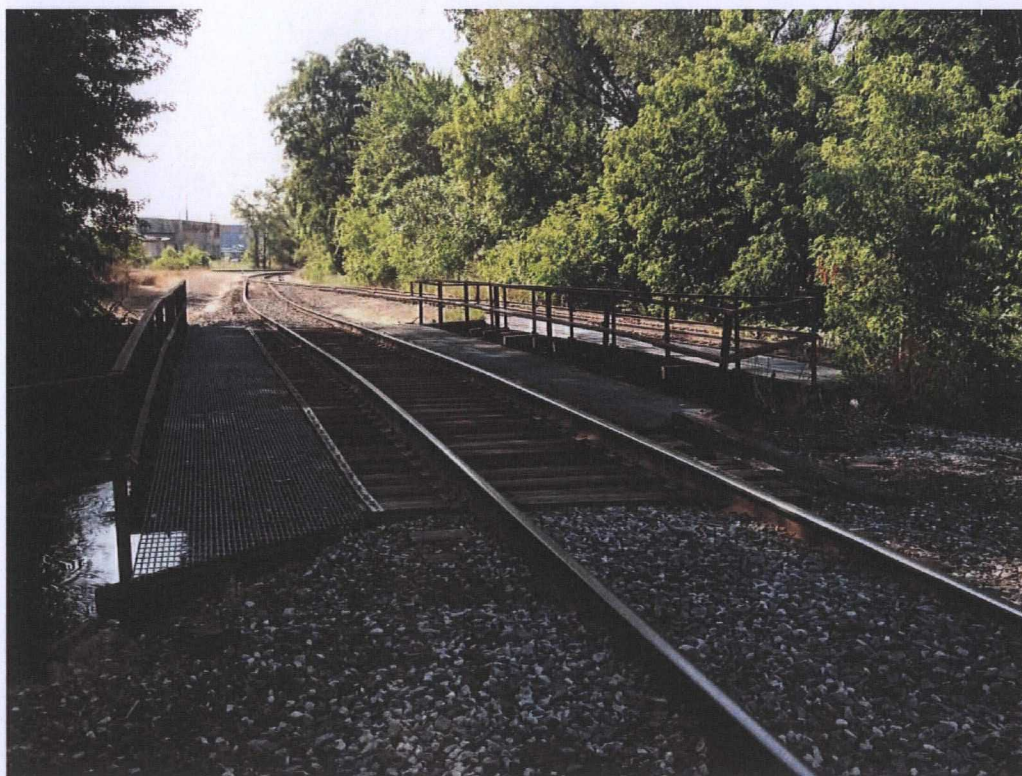
Structure viewed from track level

- If a cofferdam is required for dewatering operations, it should be located south of the 42" outlet with a minimum clearance of 4'.
- Because the structures are supported on deep foundations (timber piles), they are less susceptible to vibration and settlement as structures on shallow foundations.

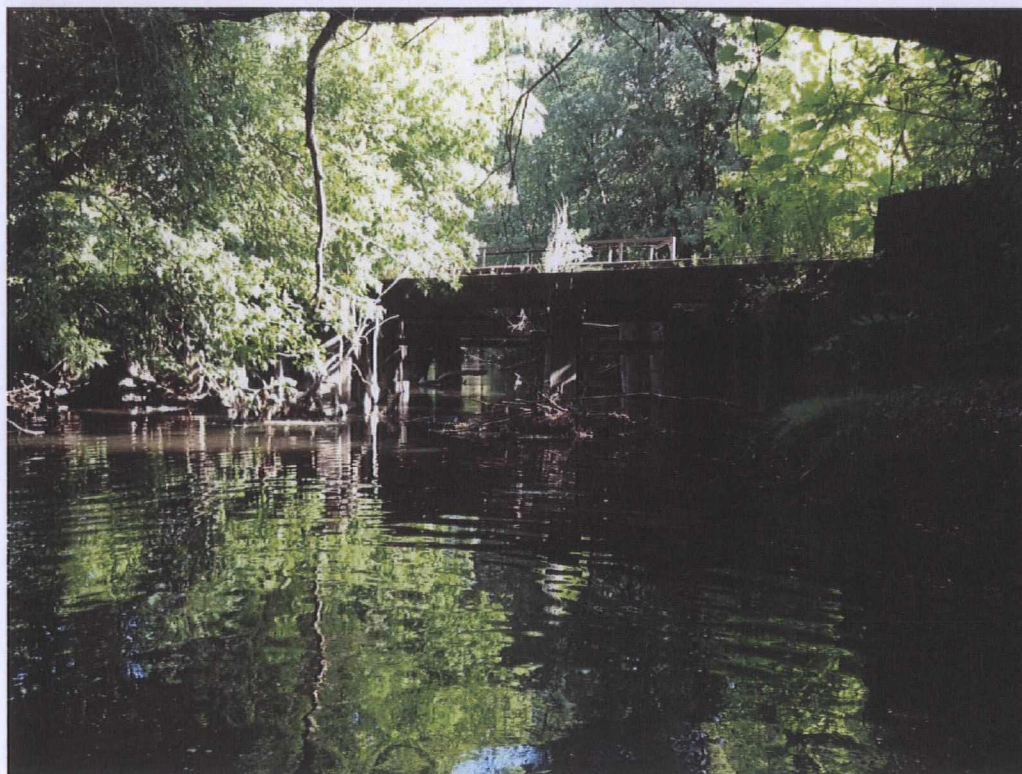
Elevation view of structure

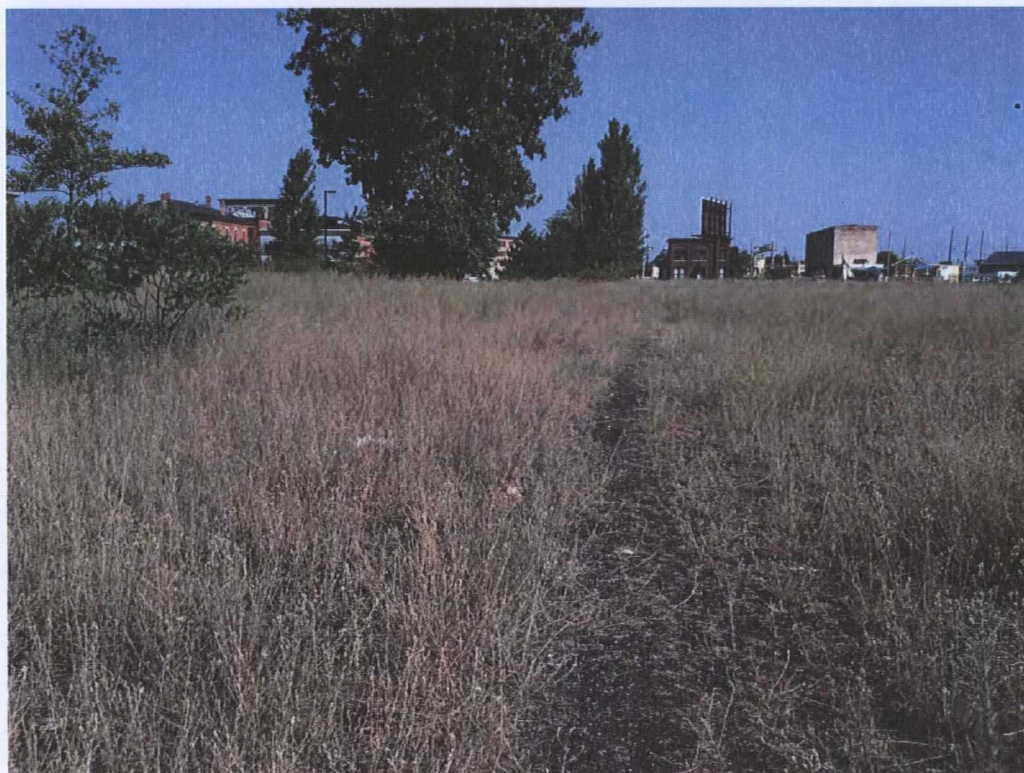
View of area looking north

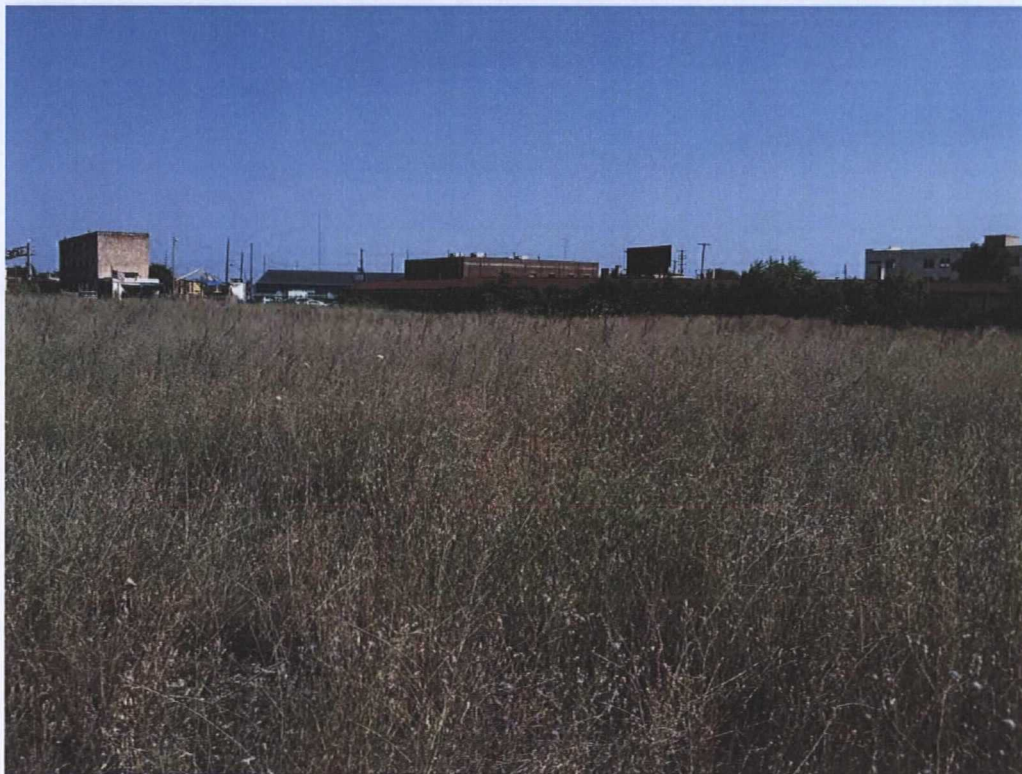
View of area looking northeast

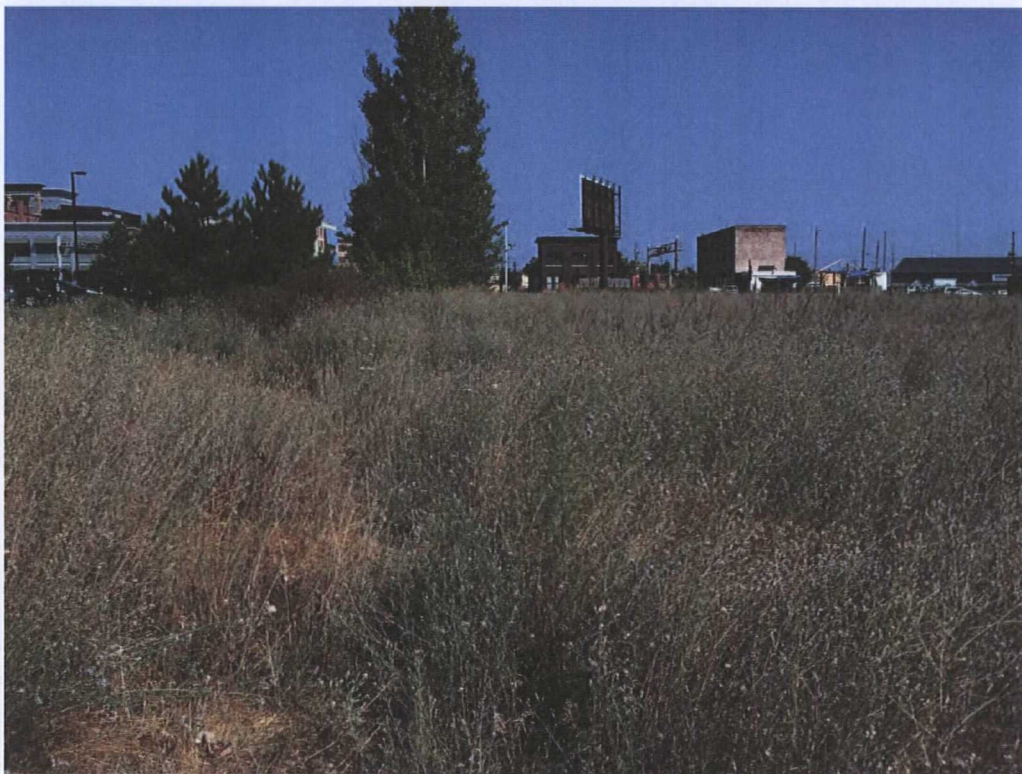
View of area looking north

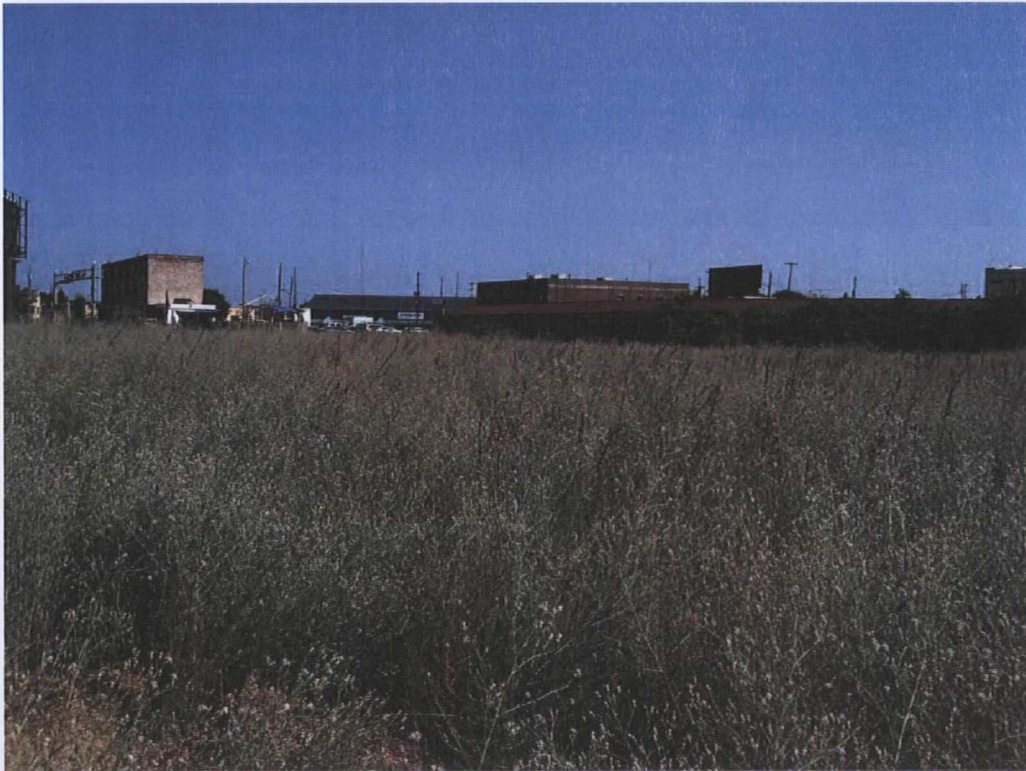
View of area looking northeast

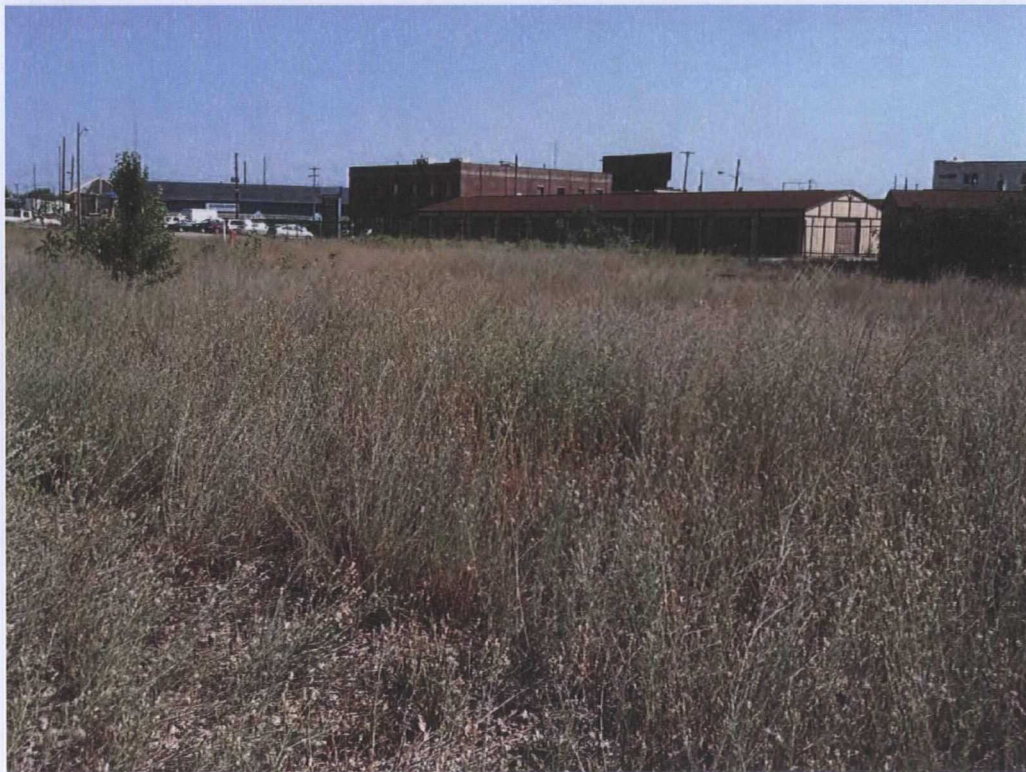
View of area looking northeast

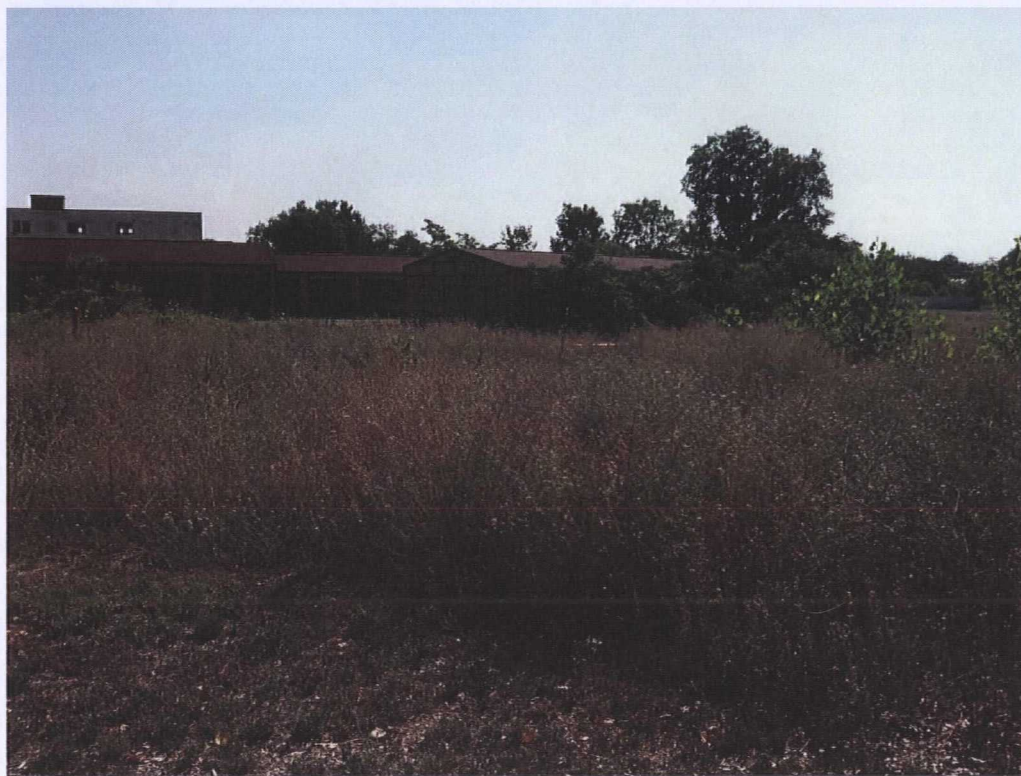
View of area looking east

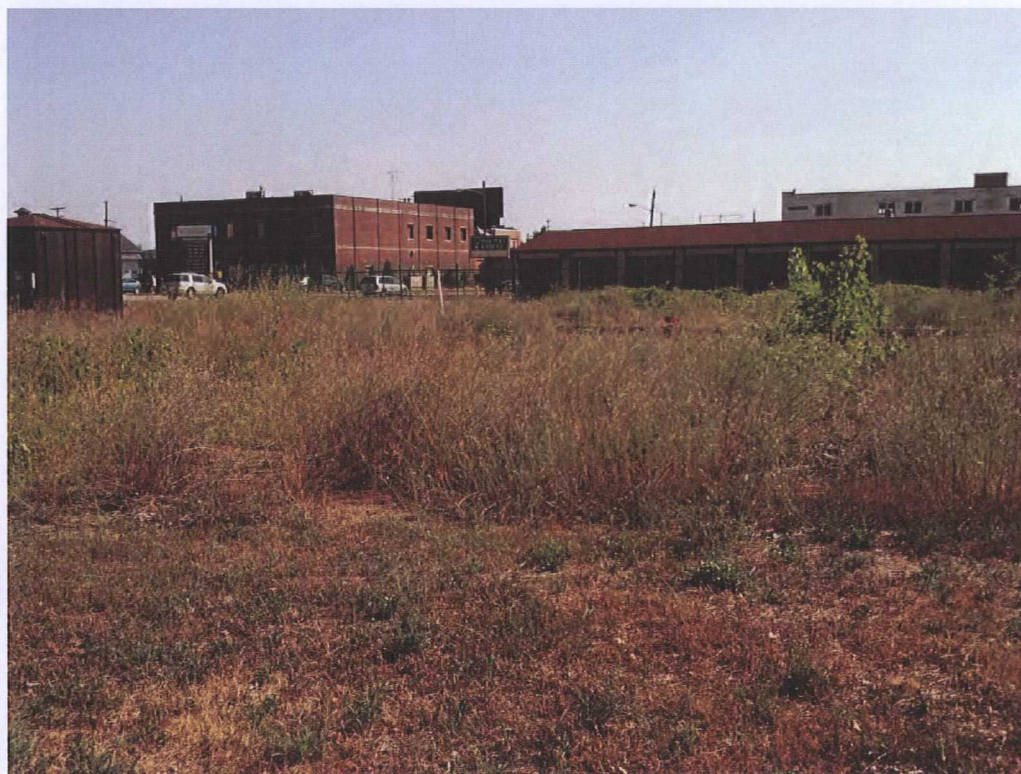
View of area looking east

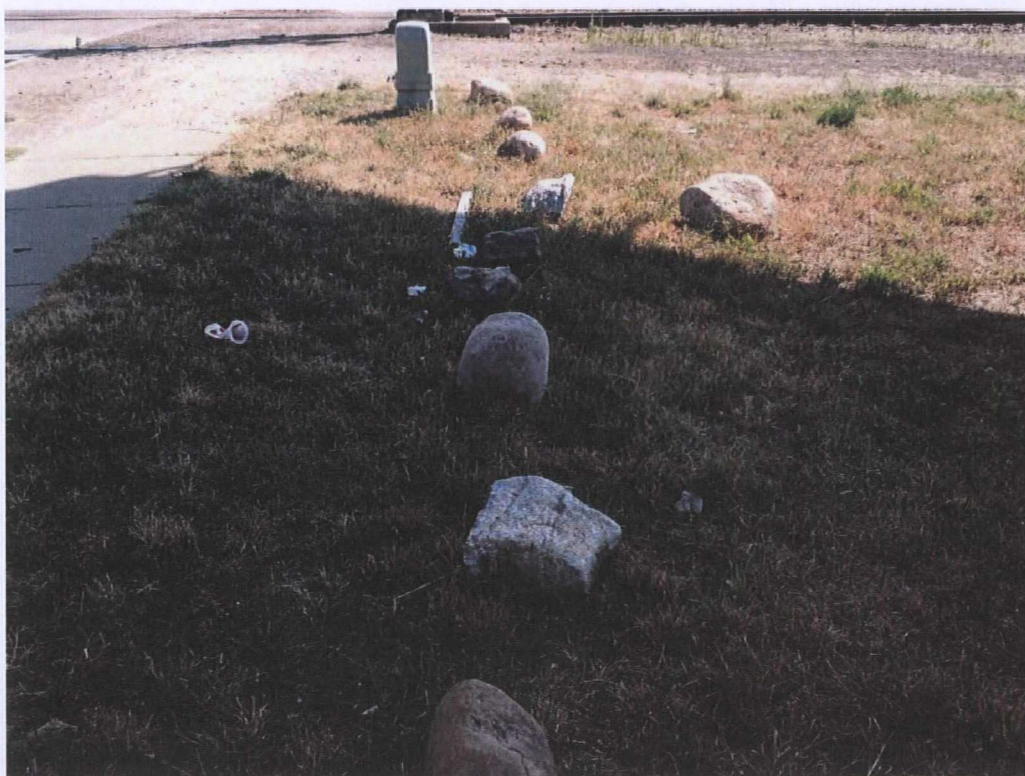
Landscape rocks at north end of field

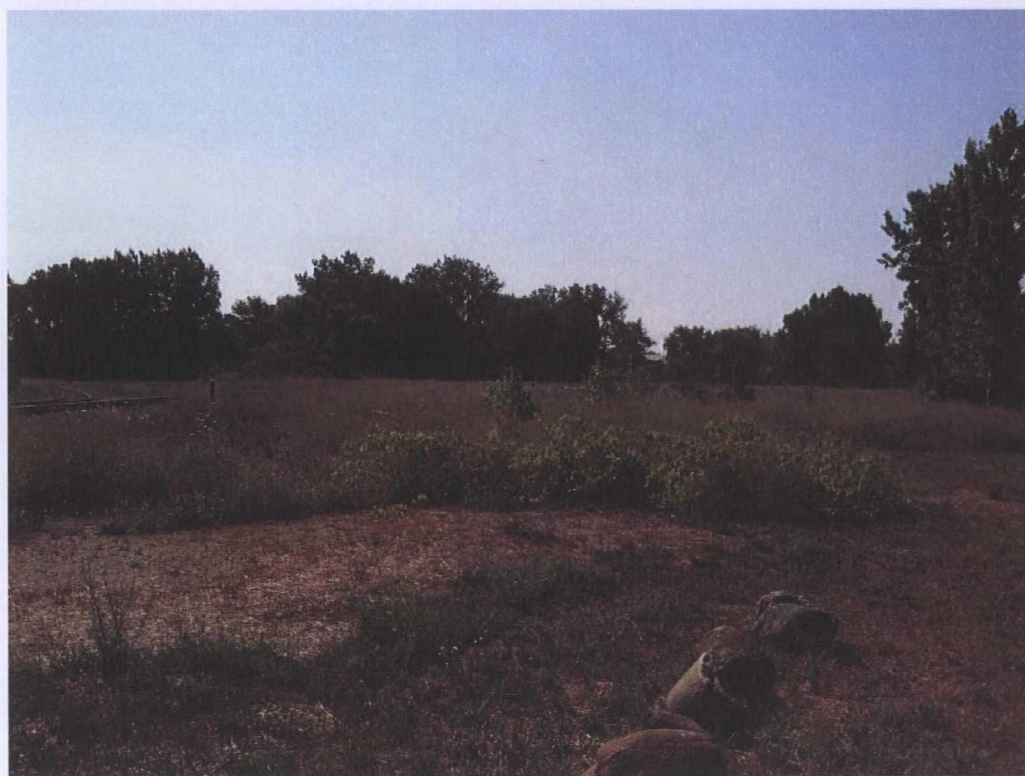
View of area looking south

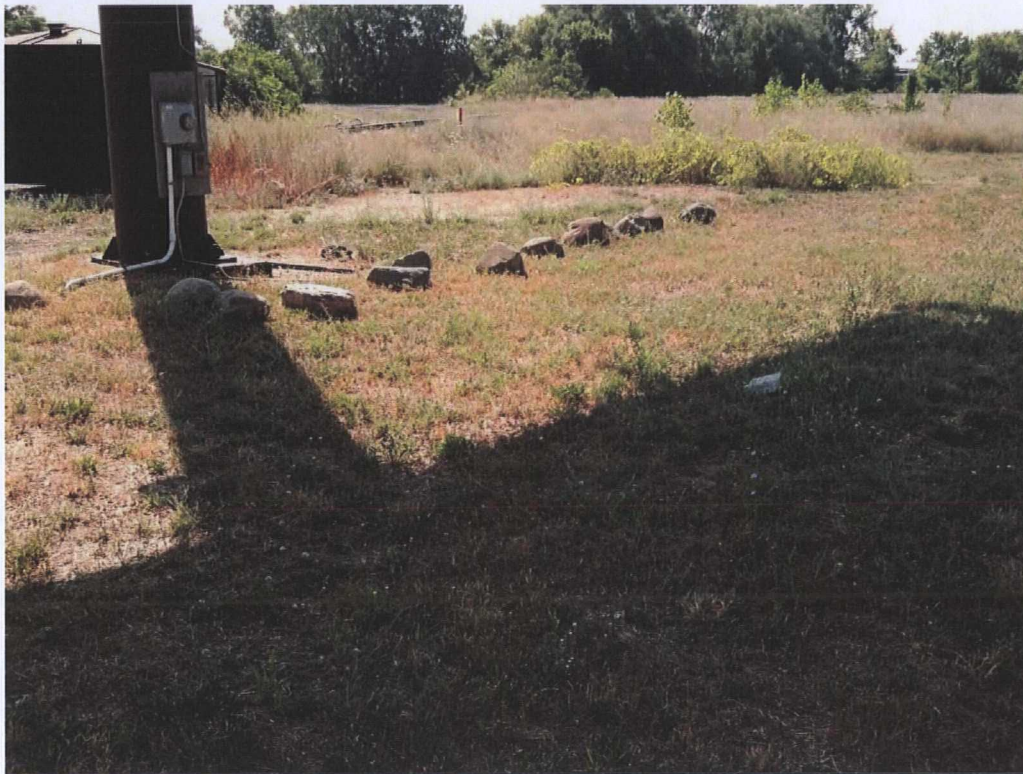
View of area looking southeast

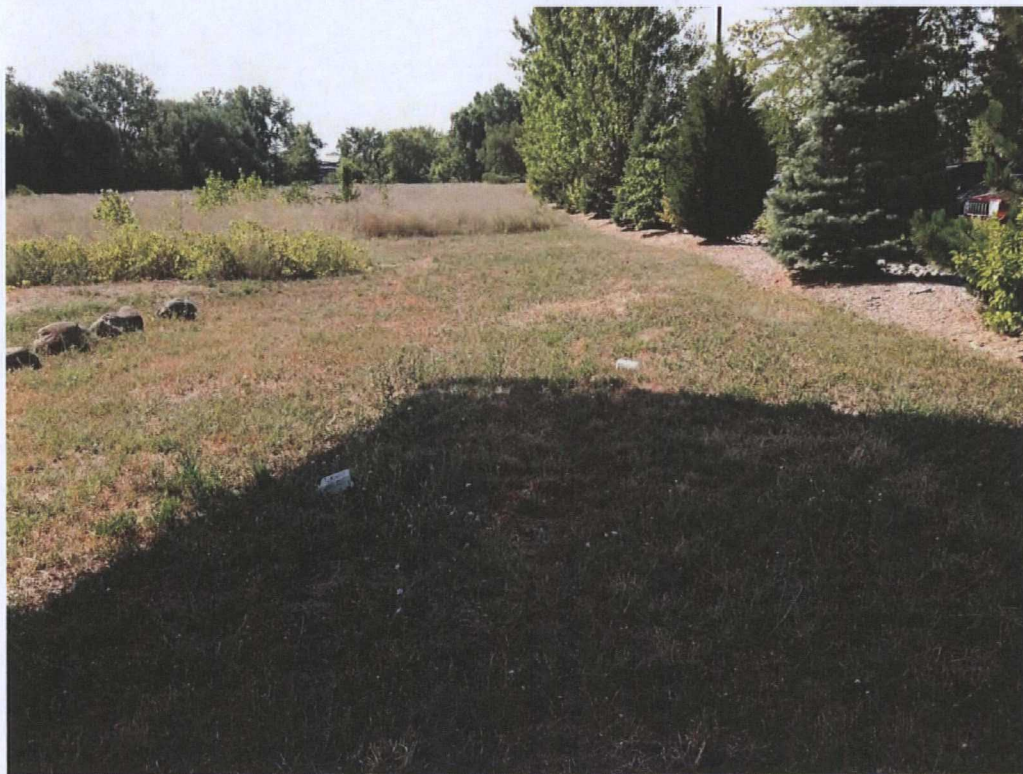
View of field along parking lot landscaping looking south

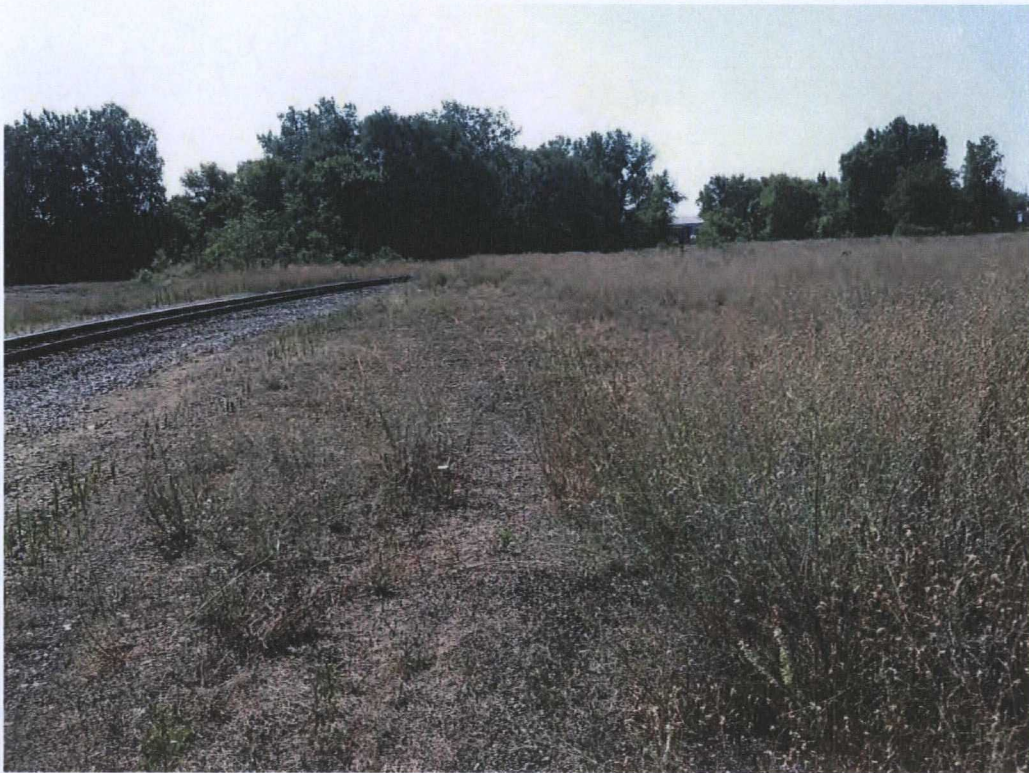
View of east side of area looking south

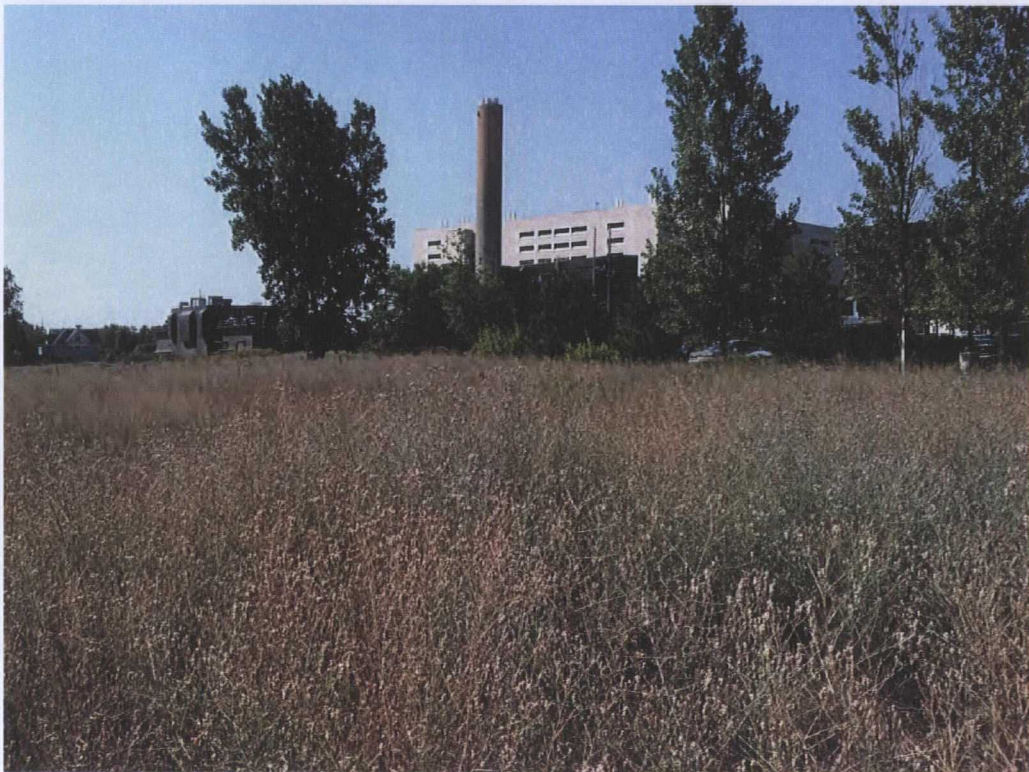
View of area looking southwest

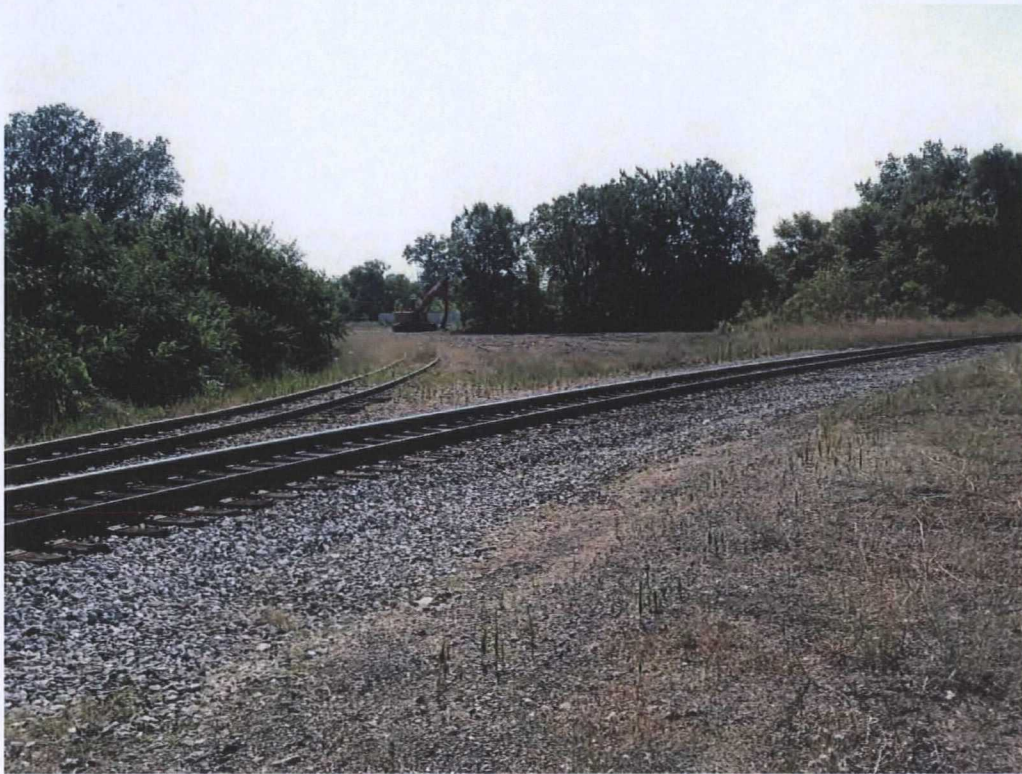
View of east side of area looking southeast

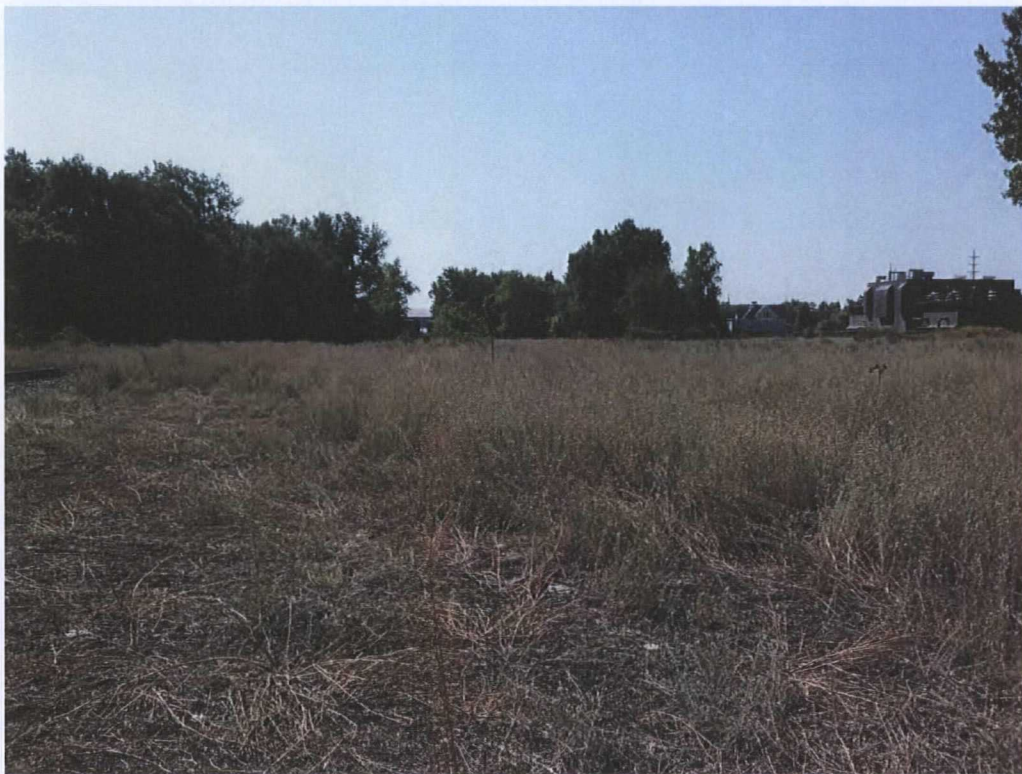
View of area looking south

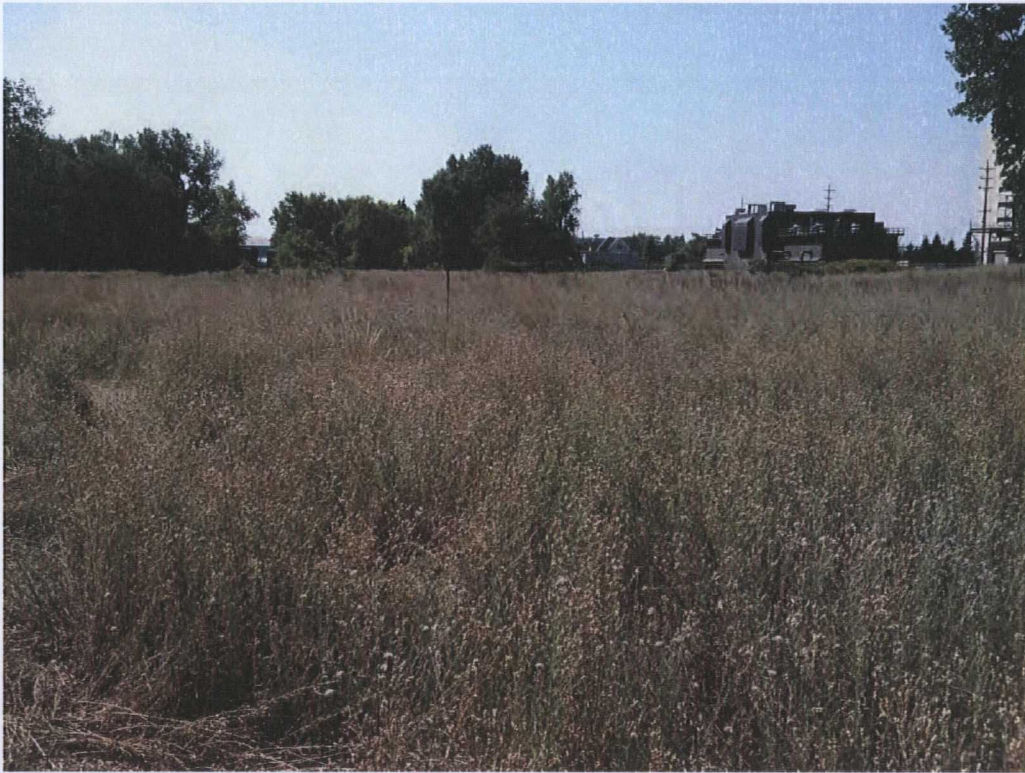
View of area looking south

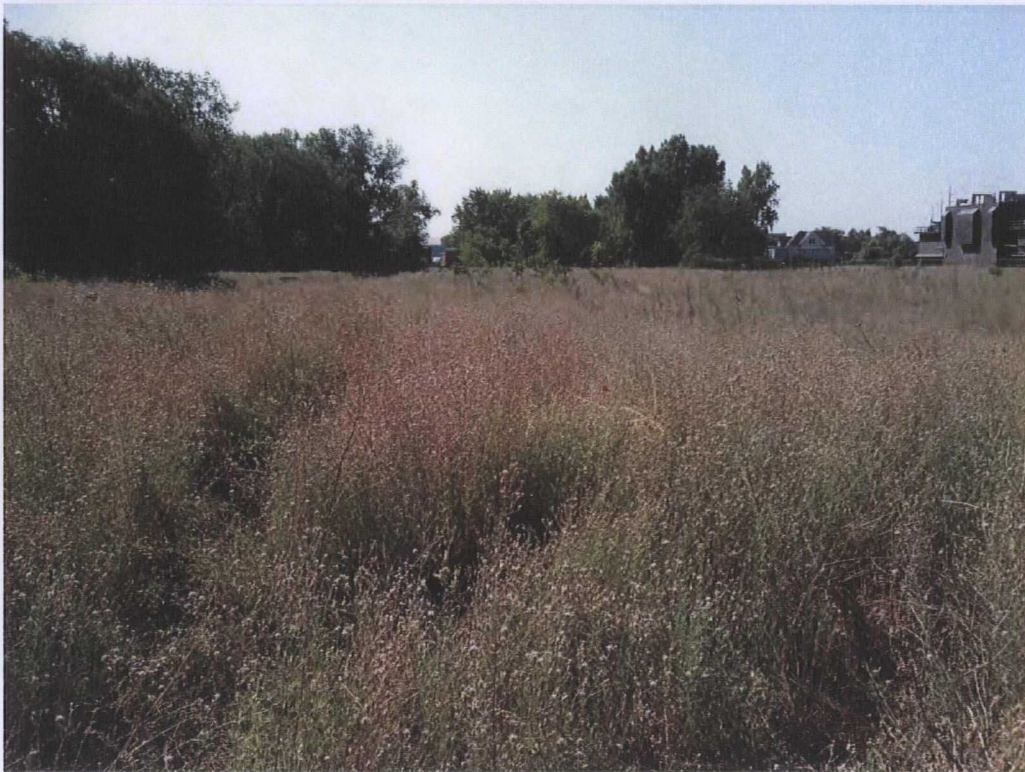
View of area SA3-A from field
